Report of Results of Additional Soil Characterization

1010 to 1024 Morse Avenue Sunnyvale, California

October 2010

Erler & Kalinowski, Inc. Burlingame, California

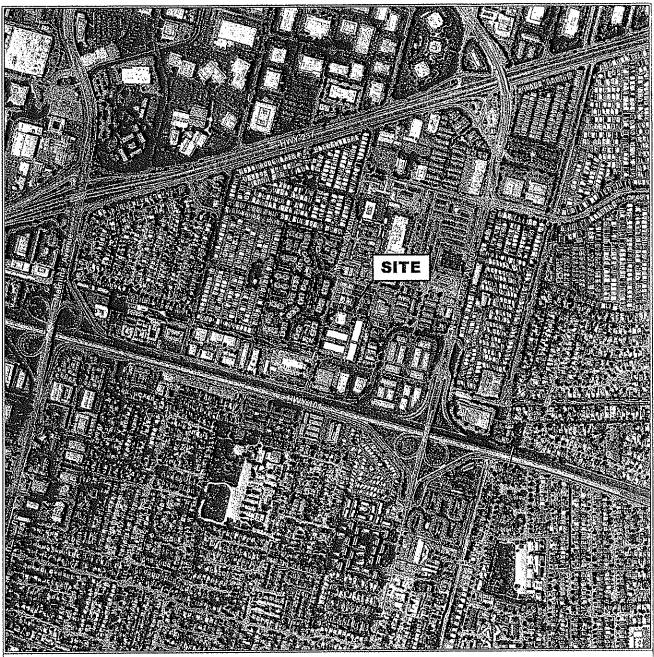
1010 - 1024 Morse Avenue Sunnyvale, CA October 2010 EKI B00015.00 Figure 1

Reference: Google Earth Pro; Imagery date June 30, 2007.

Erler & Kalinowski, Inc. ("EKI") is pleased to present to the City of Sunnyvale ("the City") this report of results of additional soil characterization at the Fair Oaks Industrial Complex ("FOIC") located at 1010 to 1024 Morse Avenue in Sunnyvale, California (herein referred to as the "Site"; see Figure 1). EKI's services were performed in accordance with our Agreement with the City, dated 25 February 2010, and an Amendment to the Agreement, dated 6 July 2010 (collectively, the "Agreement").

The Site at 1010 to 1024 Morse Avenue is located on the east side of Morse Avenue, just north of East Weddell Drive and the Hetch-Hetchy aqueduct (see Figures 1 and 2). The Site is approximately 5.3 acres in size and is identified by the following Santa Clara County Assessor's Parcel Number: APN 110-14-202. The Site is bordered to the north and east by recently-constructed residential townhome units; to the northeast by Global Crossing, a communication technology company; to the south by the Hetch-Hetchy aqueduct; and to the west by Morse Avenue and multi-family residential across Morse Avenue.
